10 Environmental Flow Assessment

The Environmental Flow Assessment (EFA) assesses the impacts on aquatic ecology and social reliance of flow alteration due to the planned operation of Ruzizi III HEPP and specifically the environmental flow of 10 m³/s as defined in the Project's Feasibility Study. The EFA provides support towards assessment of flow-related impacts but does not yield recommendations for development of mitigation.

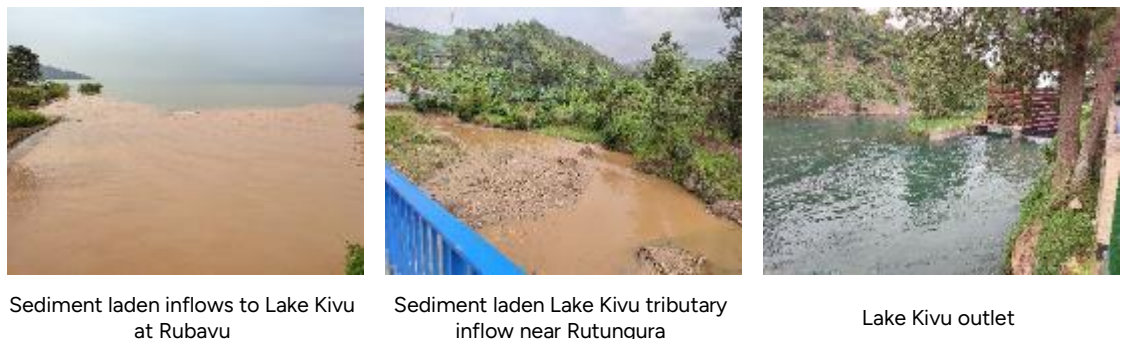
Figure 10-2 Lake Kivu catchment (Rubavu to Kamembe)

A hydrological field visit was undertaken in January 2022. This included stakeholder meetings with GIZ, the Rwanda Water Resources Board (RWB), and the Ministry of Infrastructure (MININFRA) in Kigali, and ABAKIR in Rubavu. The field visit included a drive through of the Lake Kivu catchment from Rubavu to Kamembe (Figure 10-2), a visit to Ruzizi II reservoir (Figure 10-3), a detailed walk-over of the Ruzizi River from Ruzizi III to the Ruhwa River, and water level observations at Kamanyola monitoring station (Figure 10-4). A photographic and video record of river flow conditions, and laser measure readings of selected channel features along the Ruzizi River, were obtained and used to inform the development of the reach hydraulic model.

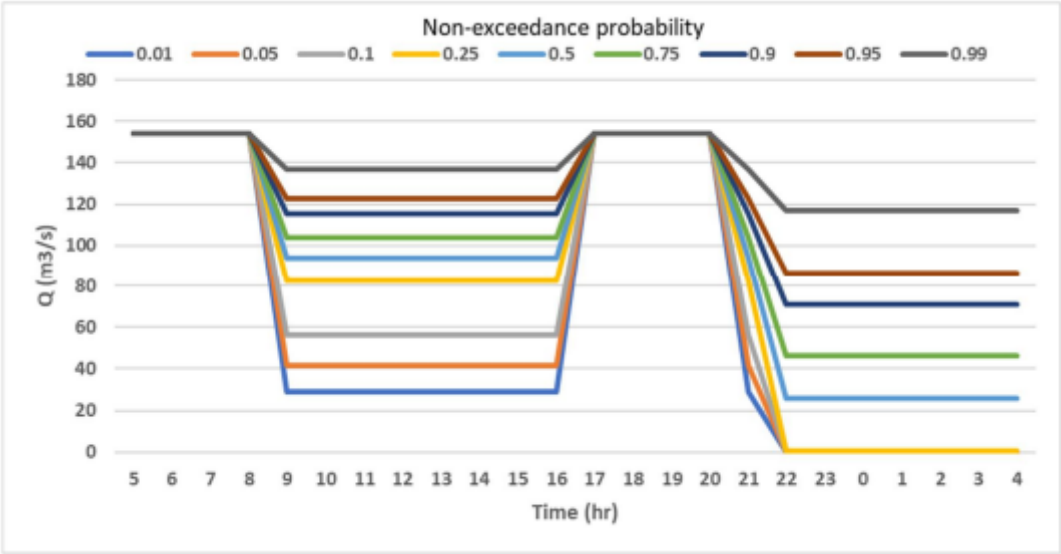
Ruzizi I

Ruzizi II

Ruzizi III

As the current baseline hydrological conditions in the Ruzizi River are not predictable, the EFA is based on the Ruzizi Cascade Model presented in the Feasibility Study (Tractebel, 2020). This explicitly takes into account the hydrological conditions in the Lake Kivu catchment as well as the optimised operational rules of Ruzizi I, Ruzizi II, and Ruzizi III. These operating conditions are based on a system-wide energy demand curve (see Figure 10-9) that divides the day into three periods: Peak Period 1; Peak Period 2; and Off-peak. Operational release curves have been defined for Ruzizi I, Ruzizi II and Ruzizi III, as shown in Figure 10-10:

- For Ruzizi I, it is optimal to release at the maximum installed capacity during the morning and afternoon peak periods. Outflow during the late-morning / early-afternoon secondary peak period and during the off-peak period vary according to hydrological condition – outflows are maximised when the reservoir level is greater than 1462.3 masl.
- For Ruzizi II, releases are constrained during the morning and afternoon peak periods due to limited storage and lag between Ruzizi I and Ruzizi II. Releases during the secondary peak period and during the off-peak period are conditioned by the Ruzizi I releases and the limited storage.

For Ruzizi III, it is optimal to release at the maximum installed capacity during the morning and afternoon peak periods. Outflow during the late-morning / early-afternoon secondary peak period and during the off-peak period vary according to hydrological condition. The high storage at Ruzizi III helps to mitigate against occurrences of “non-optimal” operation at Ruzizi II.

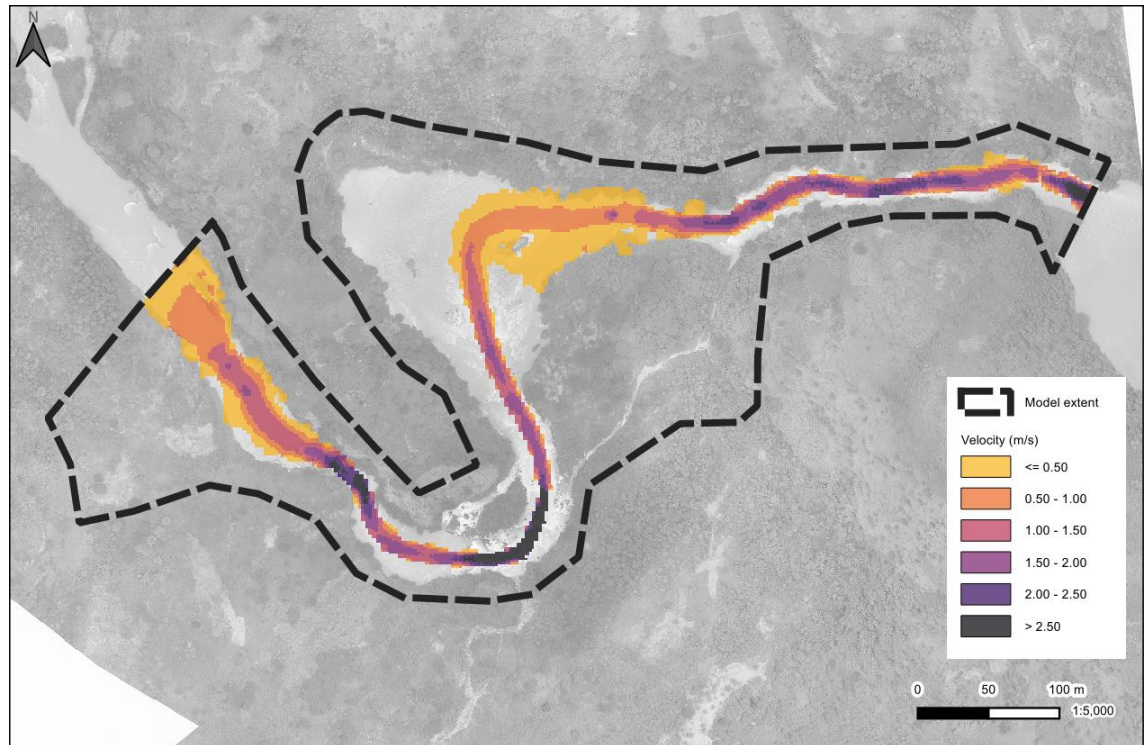
Figure 10-21 Modelled velocity for an EFlow of 10 m³/s in the reach below Ruzizi III dam wall

The hydraulic conditions in the 1 km reach below the Ruzizi III dam wall with an EFlow of 10 m³/s are further illustrated by the 2D hydraulic modelling as illustrated in Figure 10-19, Figure 10-20, and Figure 10-21.

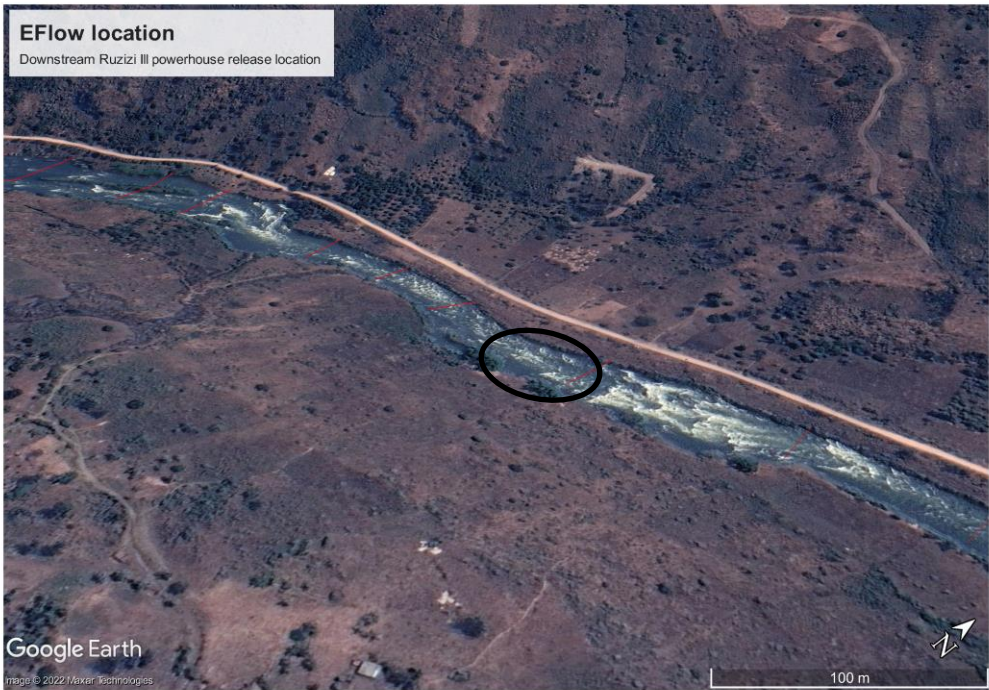
Figure 10-25 Downstream Ruzizi III Powerhouse Location

This section is located immediately downstream of the proposed Ruzizi III powerhouse. Figure 10-25 and Figure 10-26 provide a general overview of the river reach characteristics in this location. The model cross-section approximate reach is highlighted.

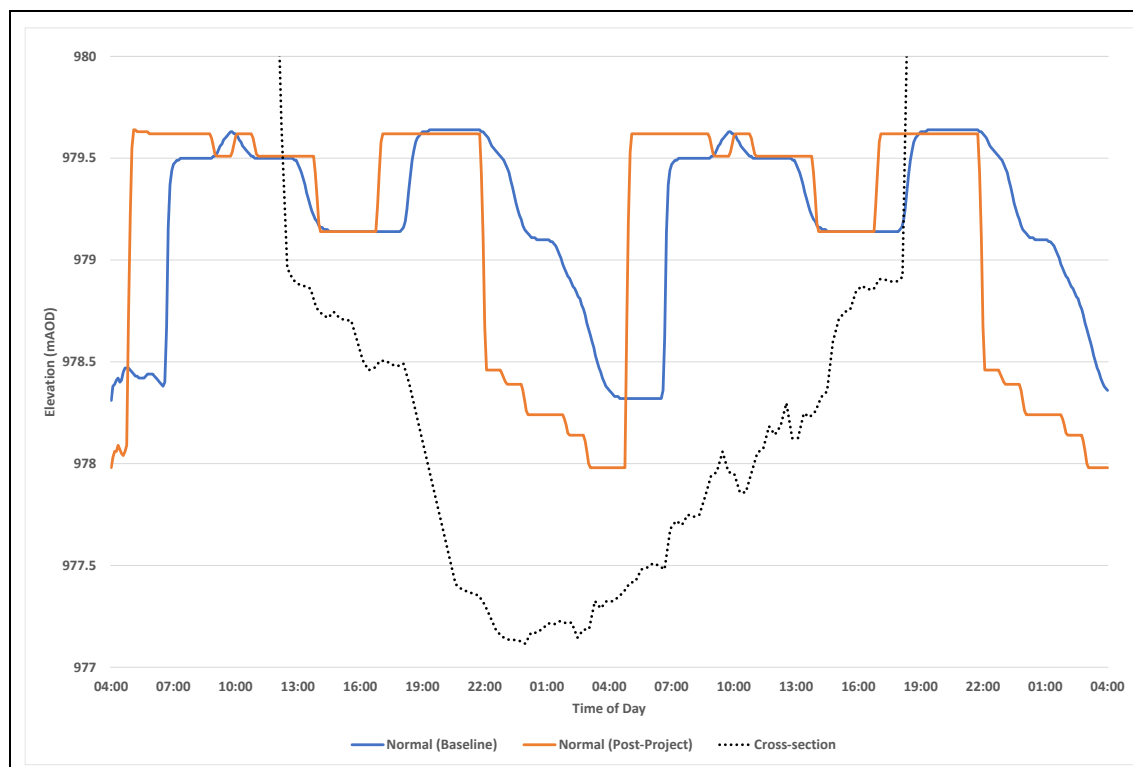
Baseline	Future
Maximum Elevation (mAOD)	979.64	979.64
Minimum Elevation (mAOD)	978.31	977.98
Elevation Range (m)	1.33	1.66

Figure 10-28 Downstream Ruzizi III Powerhouse Location – Level Summary

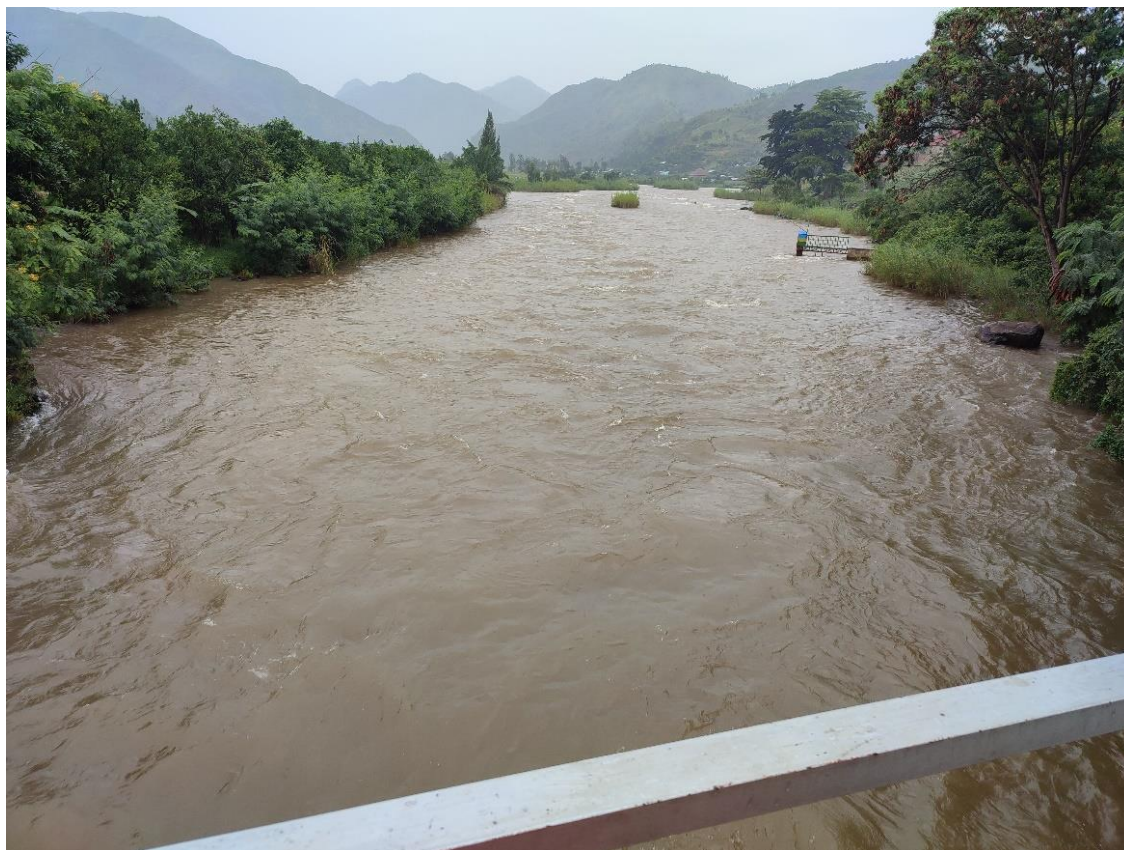
Figure 10-32 Upstream Bugarama Bridge / Kamanyola Monitoring Station – Photo

This section is located immediately approximately 4 km downstream of the start of the proposed Ruzizi III powerhouse. Figure 10-25 and Figure 10-26 provide a general overview of the river reach characteristics in this location. The model cross-section approximate reach is highlighted.

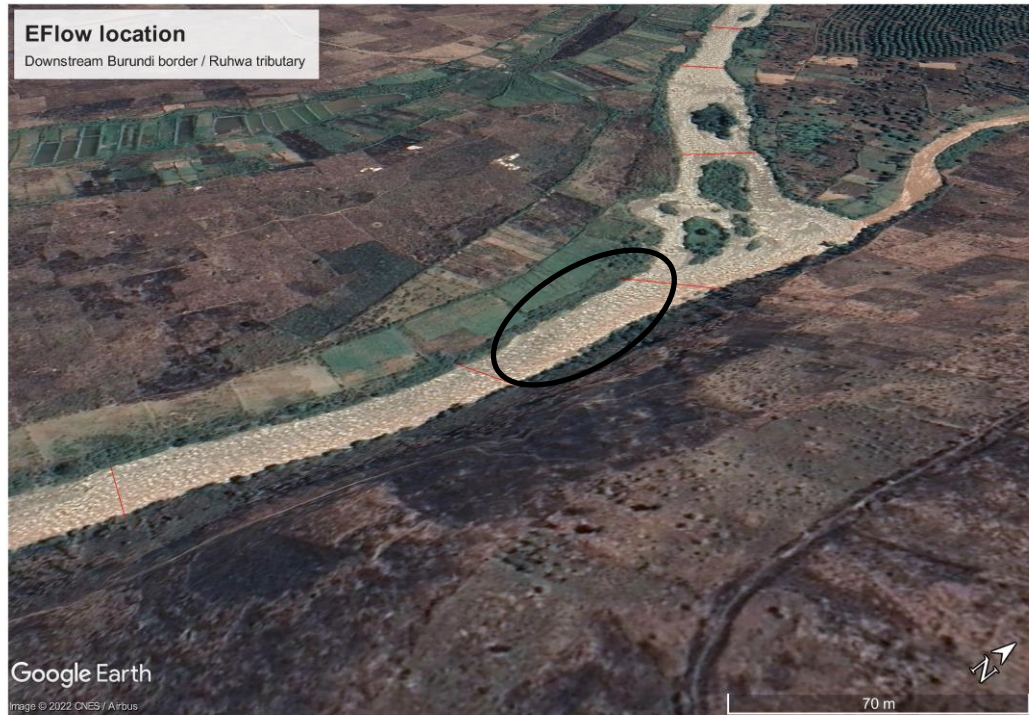
Figure 10-49 Downstream Burundi Border / Ruhwa Tributary

This section is located 10 km downstream of the proposed Ruzizi III powerhouse. Figure 10-49 and Figure 10-50 provide a general overview of the river reach characteristics in this location. The model cross-section approximate reach is highlighted.
